THE CITY OF SAN DIEGO  
**Historical Resources Board**

DATE ISSUED: July 24, 2014 REPORT NO. HRB-14-043

SUBJECT: **ITEM #5 – 1420 Granada Avenue**

DESCRIPTION: Consider the designation of the property located at 1420 Granada Avenue  
as a historical resource.

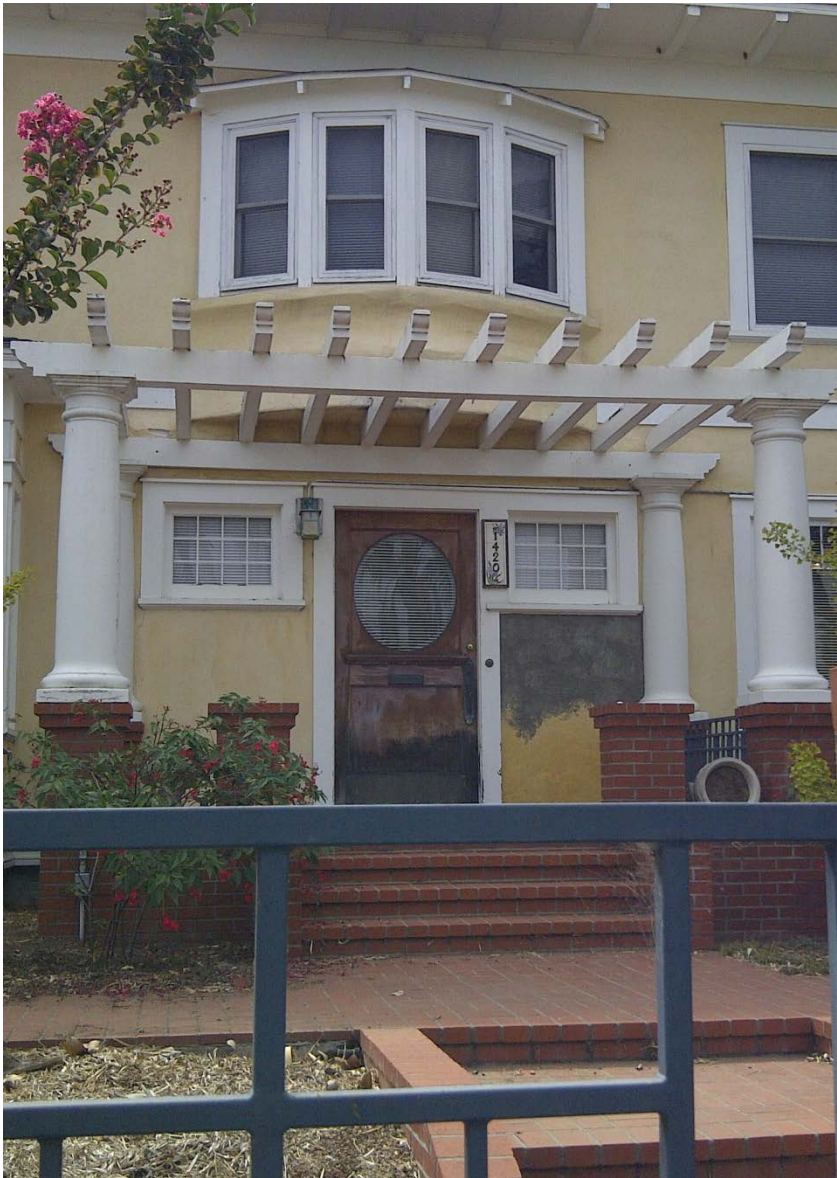
**Front Door in 2013 Prior to Unpermitted Alteration**

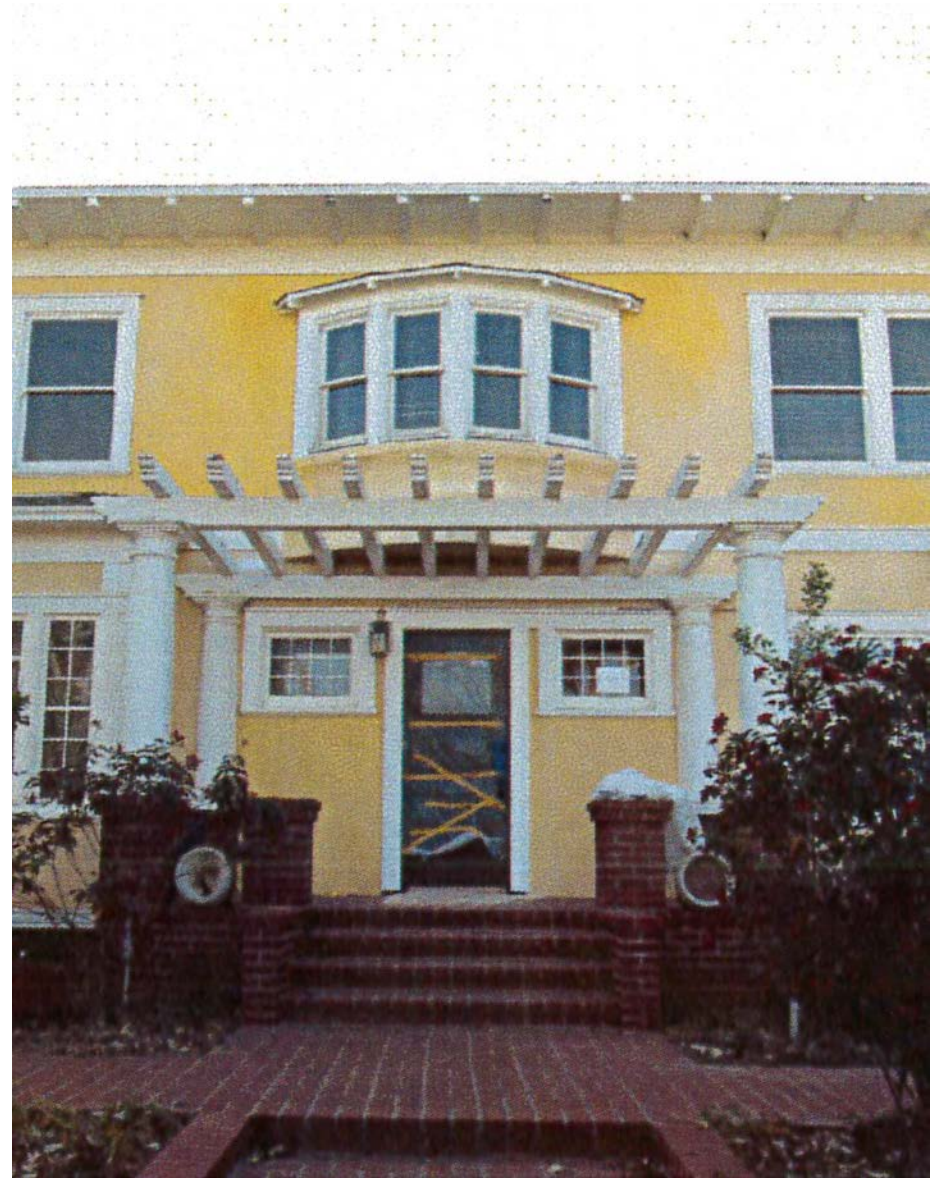
applicant opted to provide the historic report. As the alteration of the front door and side windows were not permitted, the Board may consider the building's eligibility for historic designation in its condition prior to the unpermitted alterations. The photo exhibits provided in Attachment 1 show the altered elements before and after their alteration, to assist the Board in establishing a baseline for reviewing the building. Additional photographs are provided in the applicant's report.

**Front Door After Unpermitted Alteration  
(Door Replaced and Opening Narrowed)**

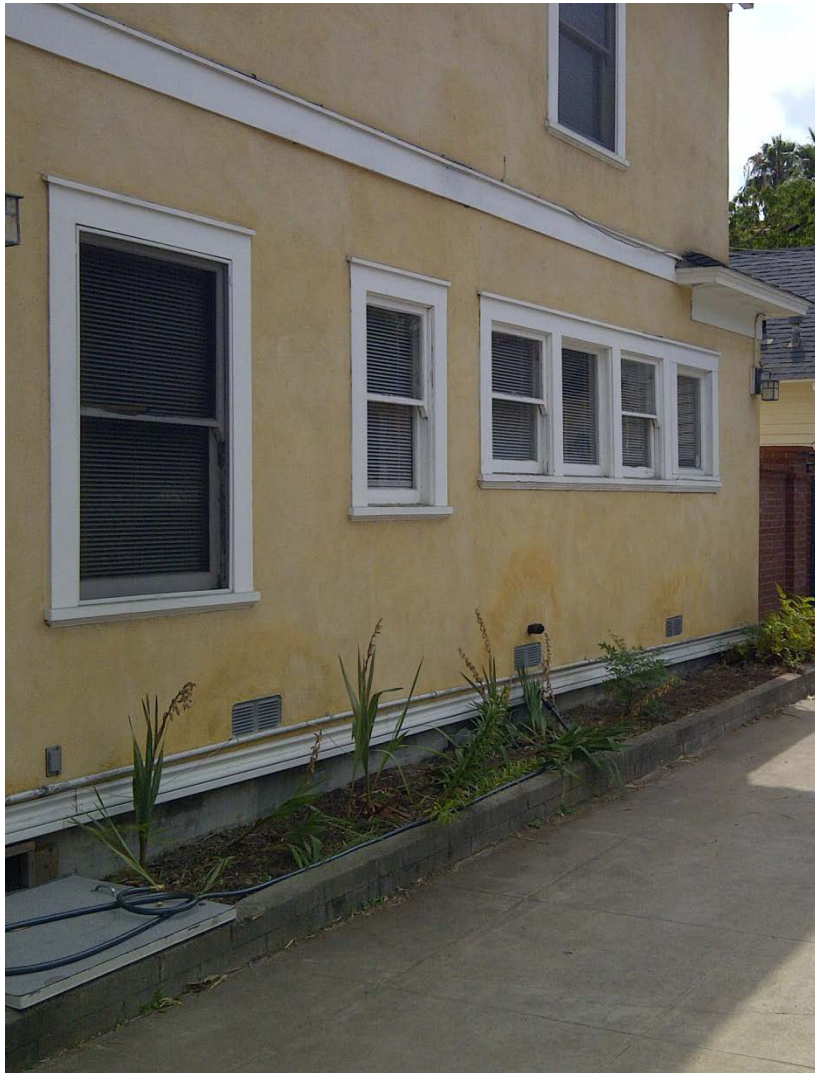
**Side Windows in 2013 Prior to Unpermitted Alteration**

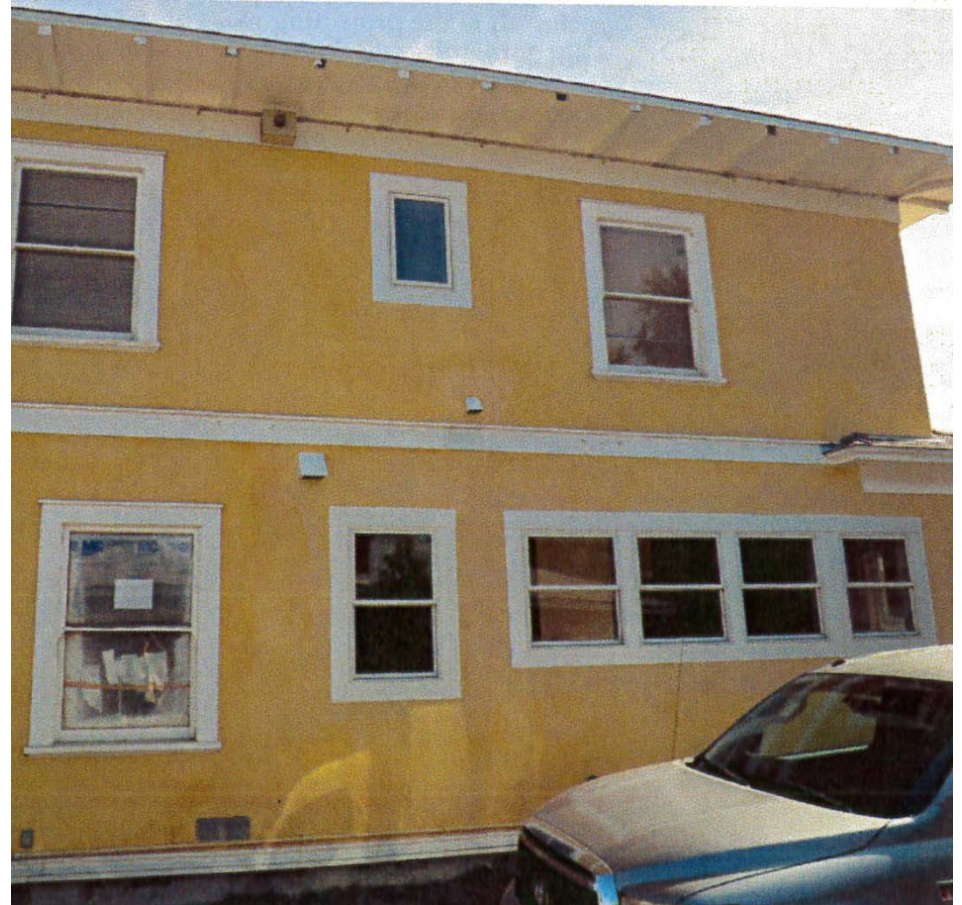
**Side Windows After Unpermitted Alteration  
(Casing/Trim Removed, Sizes Altered)**

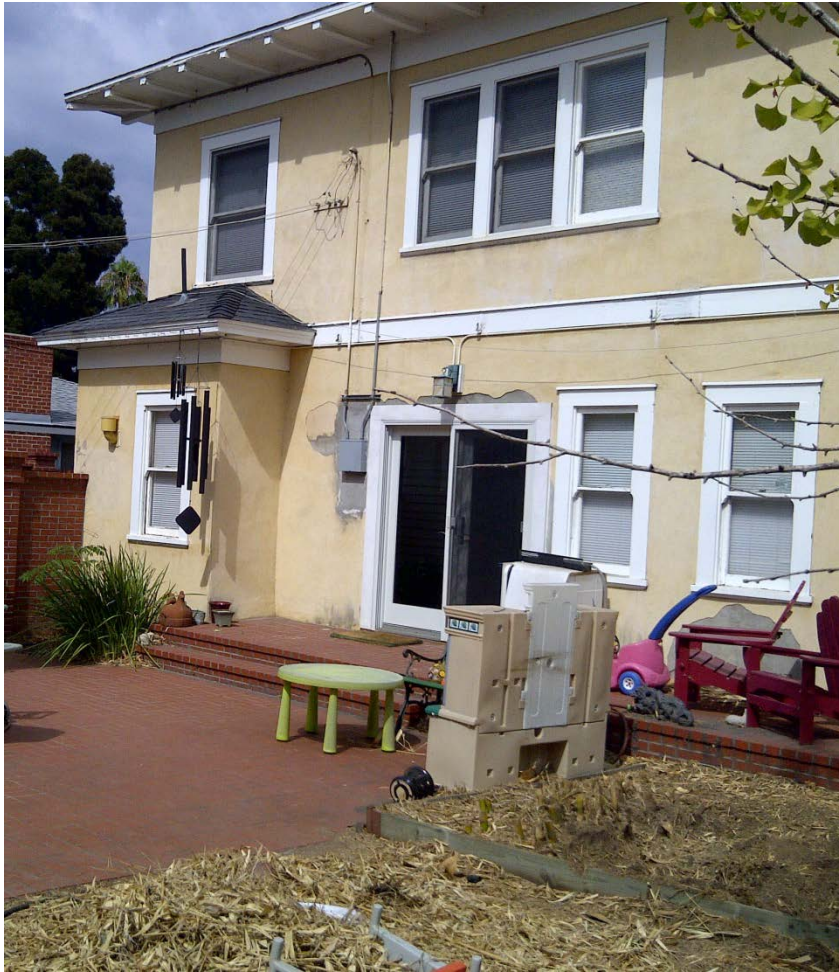
Rear in 2013 Prior to Unpermitted Alteration

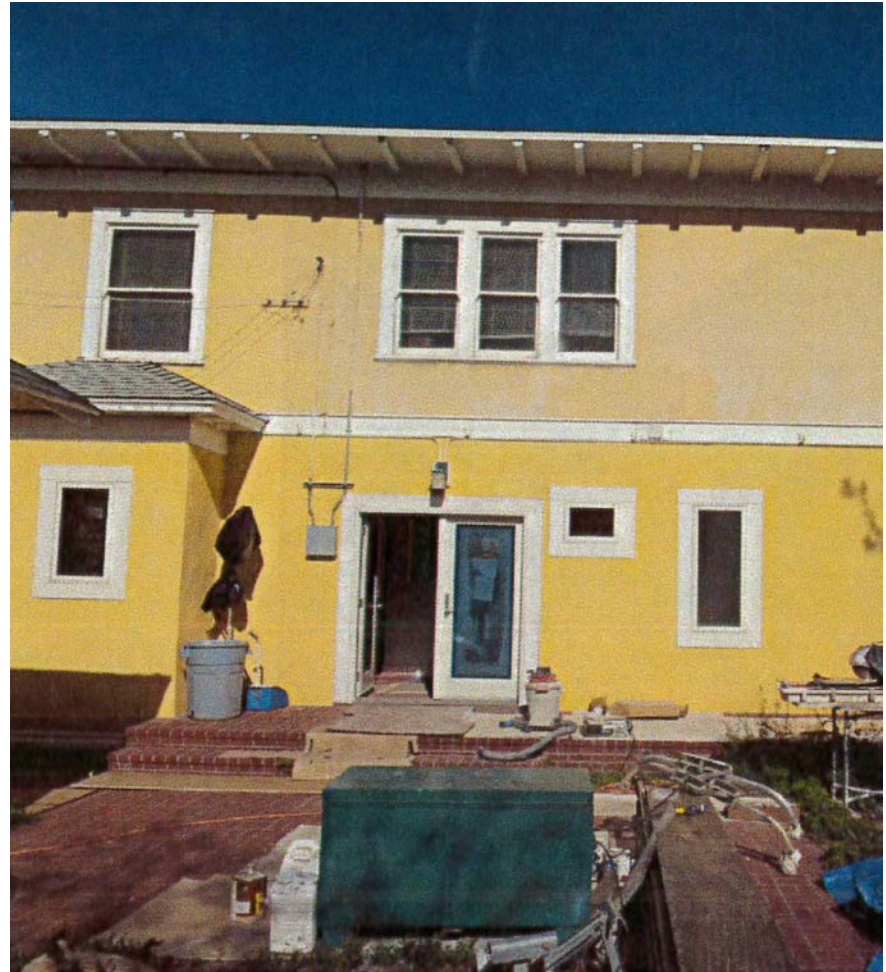
Rear After Unpermitted Alteration
