# PRIORITY DEVELOPMENT PROJECT (PDP) STORM WATER QUALITY MANAGEMENT PLAN (SWQMP) FOR

#### 2072 Via Casa Alta

Labib Funk & Associates 319 Main St. El Segundo, CA, 90245 (213)239-3922

January 13, 2025

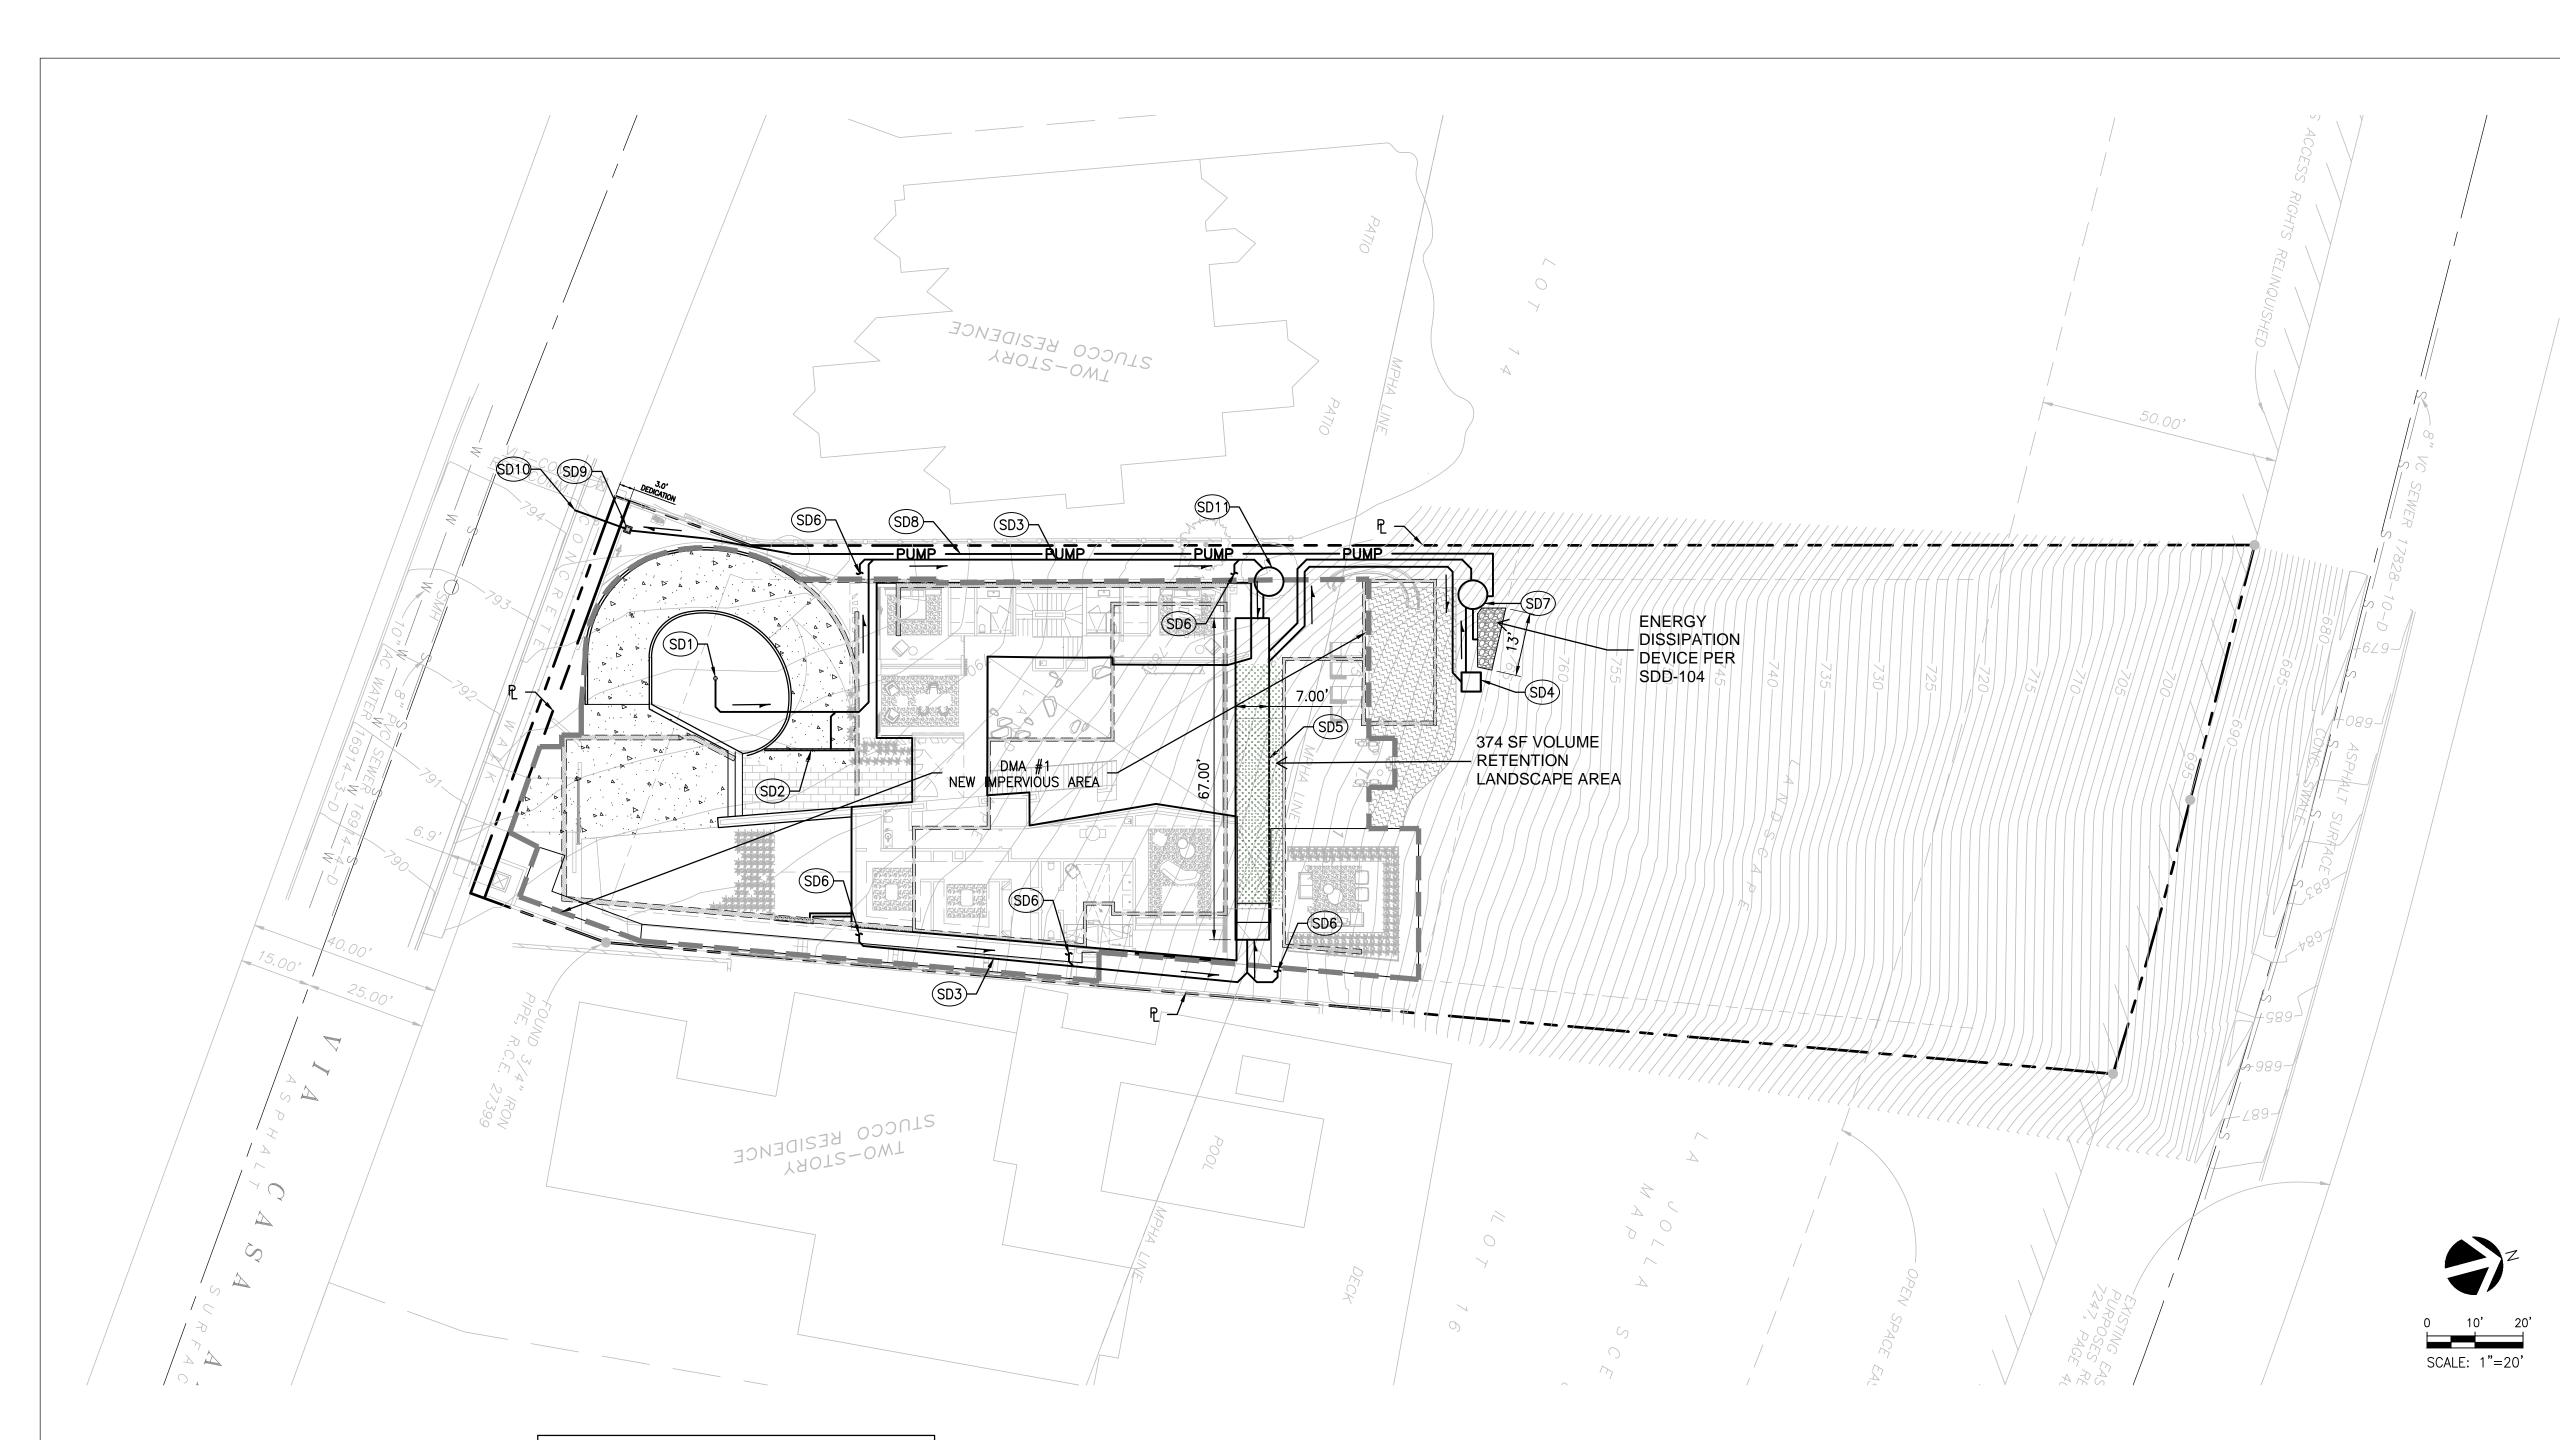
LLOLIND	
	PROPERTY LINE
	CONCRETE PAVING
* * * * * *	PLANTER AREA
	BASEMENT BUILDING
	RETAINING WALL

Attachment	Contents	Checklist
Sequence		
Attachment 1a	DMA Exhibit (Required)  See DMA Exhibit Checklist.	✓ Included
Attachment 1b	Tabular Summary of DMAs Showing DMA ID matching DMA Exhibit, DMA Area, and DMA Type (Required)*  *Provide table in this Attachment OR on DMA Exhibit in Attachment 1a	☐ Included on DMA Exhibit in Attachment 1a☐ Included as Attachment 1b, separate from DMA Exhibit
Attachment 1c	Form I-7, Harvest and Use Feasibility Screening Checklist (Required unless the entire project will use infiltration BMPs)  Refer to Appendix B.3-1 of the BMP Design Manual to complete Form I-7.	<ul><li>☑ Included</li><li>☑ Not included because the entire project will use infiltration BMPs</li></ul>
Attachment 1d	Form I-8, Categorization of Infiltration Feasibility Condition (Required unless the project will use harvest and use BMPs)  Refer to Appendices C and D of the BMP Design Manual to complete Form I-8.	<ul><li>☑ Included</li><li>☑ Not included because the entire project will use harvest and use BMPs</li></ul>
